# **INDOOR AIR QUALITY ASSESSMENT**

**Lexington Public Library  
East Branch  
795 Massachusetts Avenue  
Lexington, Massachusetts**

Prepared by:  
Massachusetts Department of Public Health  
Center for Environmental Health  
Emergency Response/Indoor Air Quality Program  
February 2007

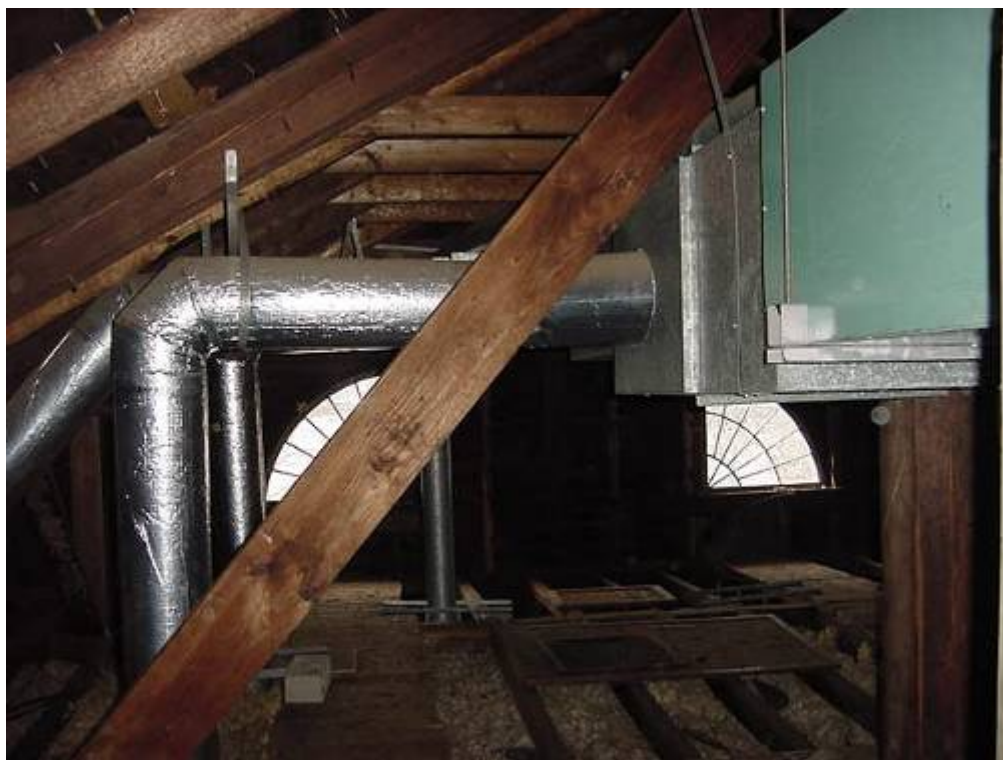
**Picture 1**

**Air Handling Unit and Ductwork in Attic**

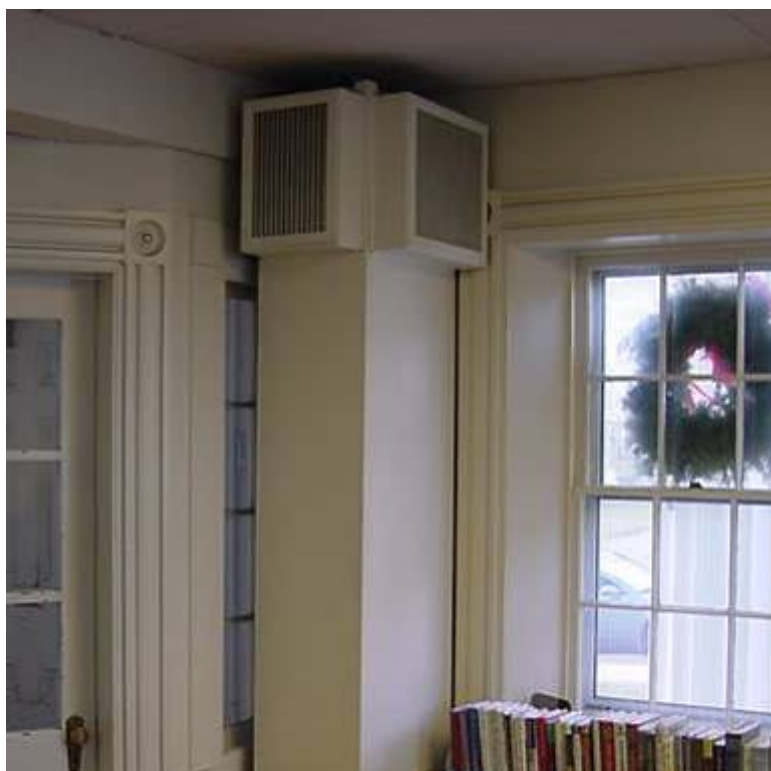
**Picture 2**

**Ducted Supply Vents Flanking Front Entrance**

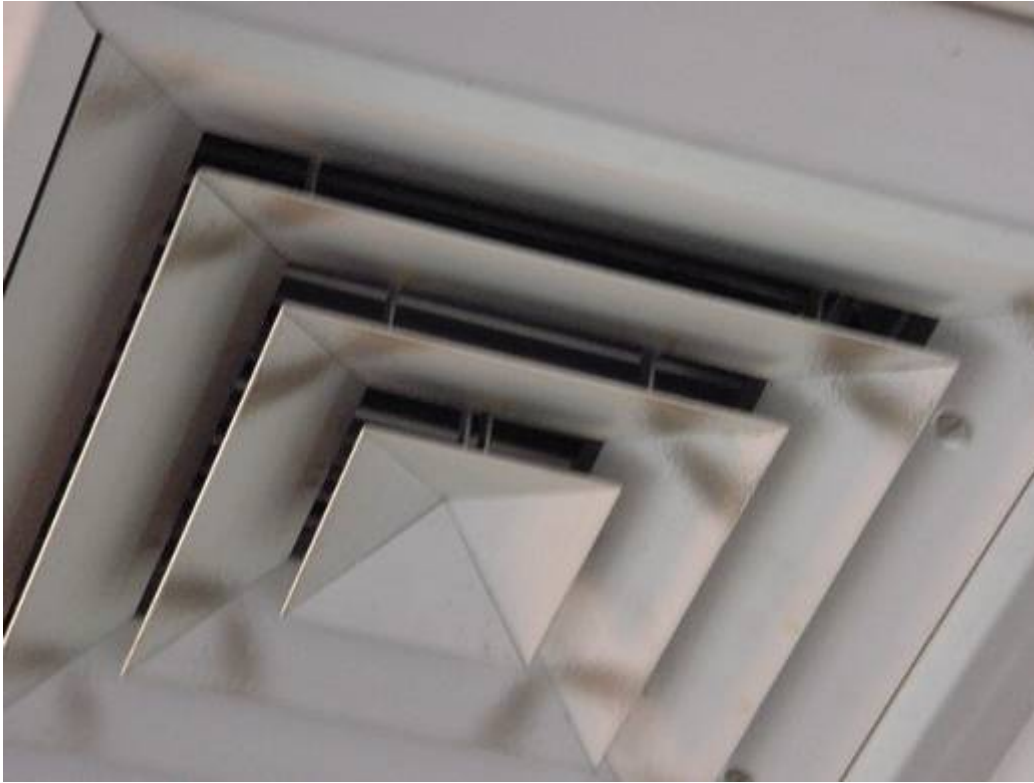
**Picture 3**

**Ceiling-Mounted Supply Diffuser, Note Dust Accumulation**

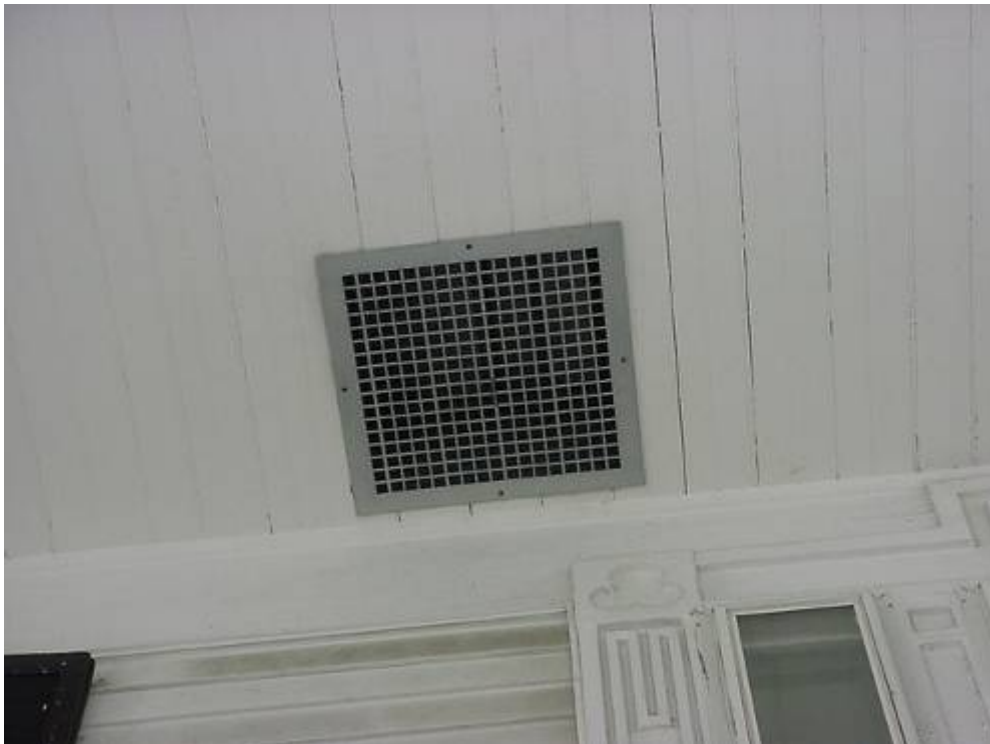
**Picture 4**

A modern air conditioning (AC) system was later retro-fitted. According to building occupants, the system is only activated during the cooling season; therefore it was deactivated during the assessment. The system consists of two air handling units (one in the basement and one in the attic) that deliver conditioned air throughout the building via ducted air diffusers (Pictures 1 through 3). Fresh air is introduced into the system via vents located on the exterior of the building (Picture 4). Air is returned back to the AHUs via ceiling mounted grills.

**Fresh Air Intake for HVAC System (Front Entrance)**

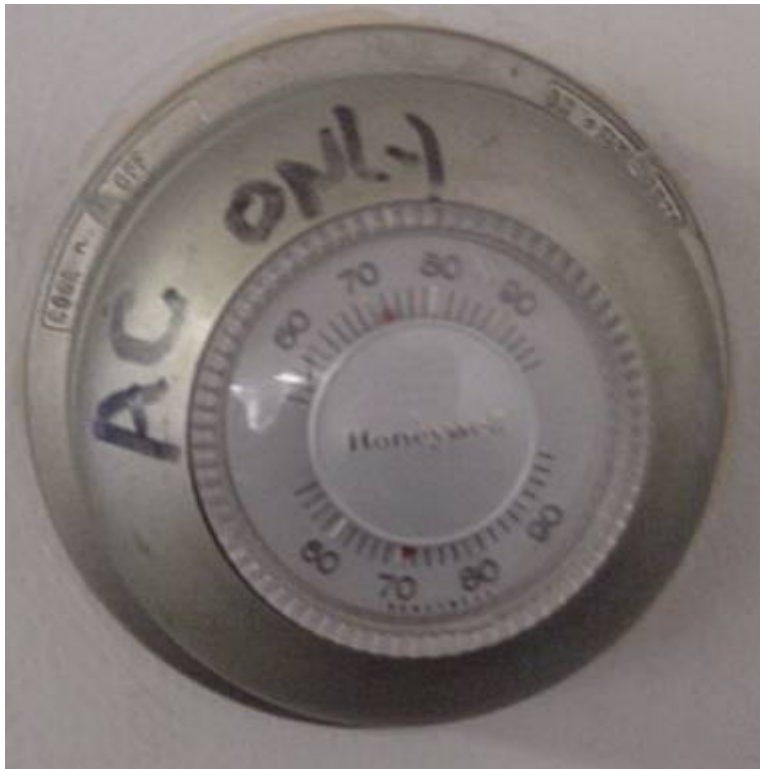
**Picture 5**

Thermostats that control the AC system have fan settings of “on” and “automatic” (Picture 5). When thermostats are set to the fan “on” setting they provide continuous airflow, which is recommended by the MDPH. The “automatic” setting on the thermostat activates the HVAC system at a preset temperature; once the preset temperature is reached, the HVAC system deactivates.

**HVAC Thermostat, Fan Switch at Right/Top**

7. Contact the town's HVAC vendor to determine if the AC system can be operated year-round to provide air exchange. Operate the system in the fan "on" mode (as opposed to the fan "auto" setting) to provide continuous air circulation and supplement the use of windows.

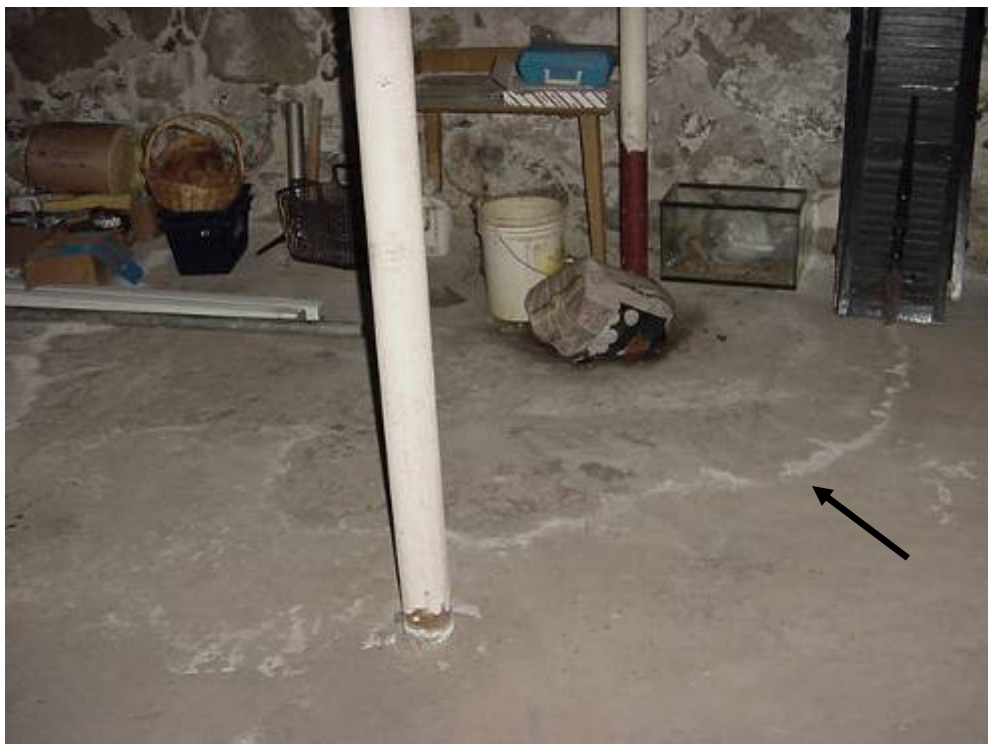
**Picture 6**

As mentioned, the primary concern prompting the request for an IAQ assessment was related to musty odors and potential mold growth in the basement. CEH staff examined the basement and detected a number of odors related to stored materials and stagnant air. The basement has no means of mechanical ventilation to remove odors. The basement is below grade, making it prone to moisture accumulation. A number of water damaged porous materials were observed in the basement including cardboard boxes, paper and sections of

carpeting (Pictures 6 through 9). Porous materials like cardboard and carpeting can provide a medium for microbial growth, especially if moistened repeatedly.

**Water Damaged Porous Materials Stored on Basement Floor, Note Water Mark Indicating Historic Water Penetration**

1. Refrain from storing porous materials in basement storage room. Inspect and discard any water damaged/mold colonized materials. Disinfect any areas of microbial growth with a mild detergent or antimicrobial, wipe clean surfaces with soap and water after disinfection.

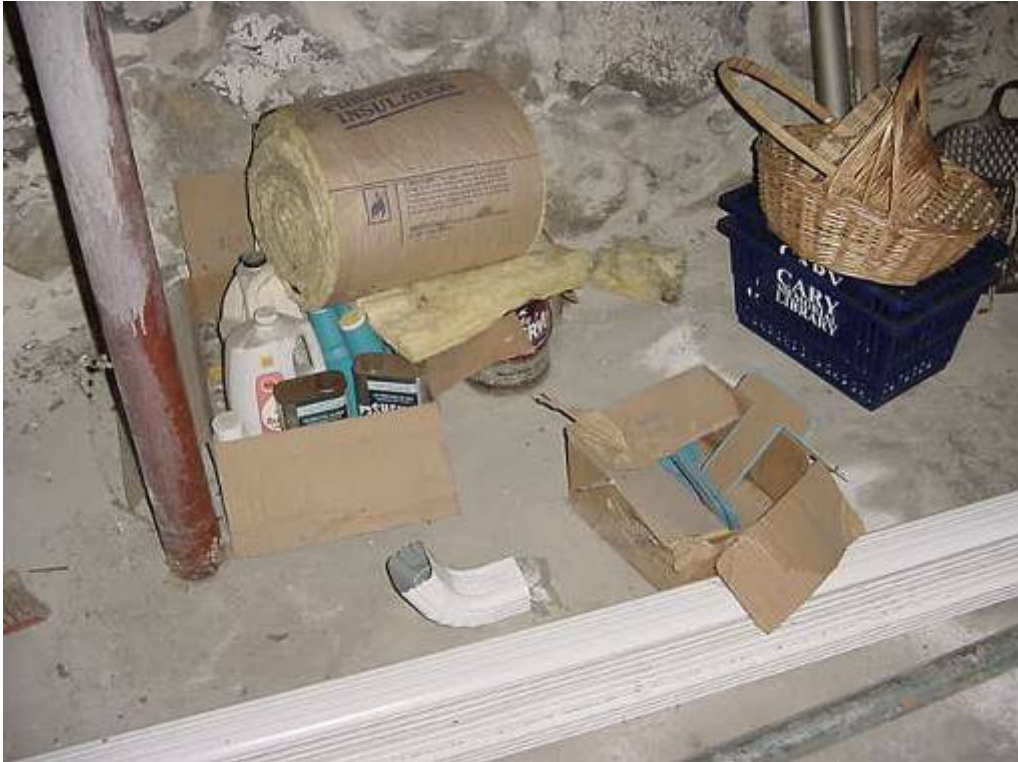
**Picture 7**

**Water Damaged Porous Materials Stored on Basement Floor**

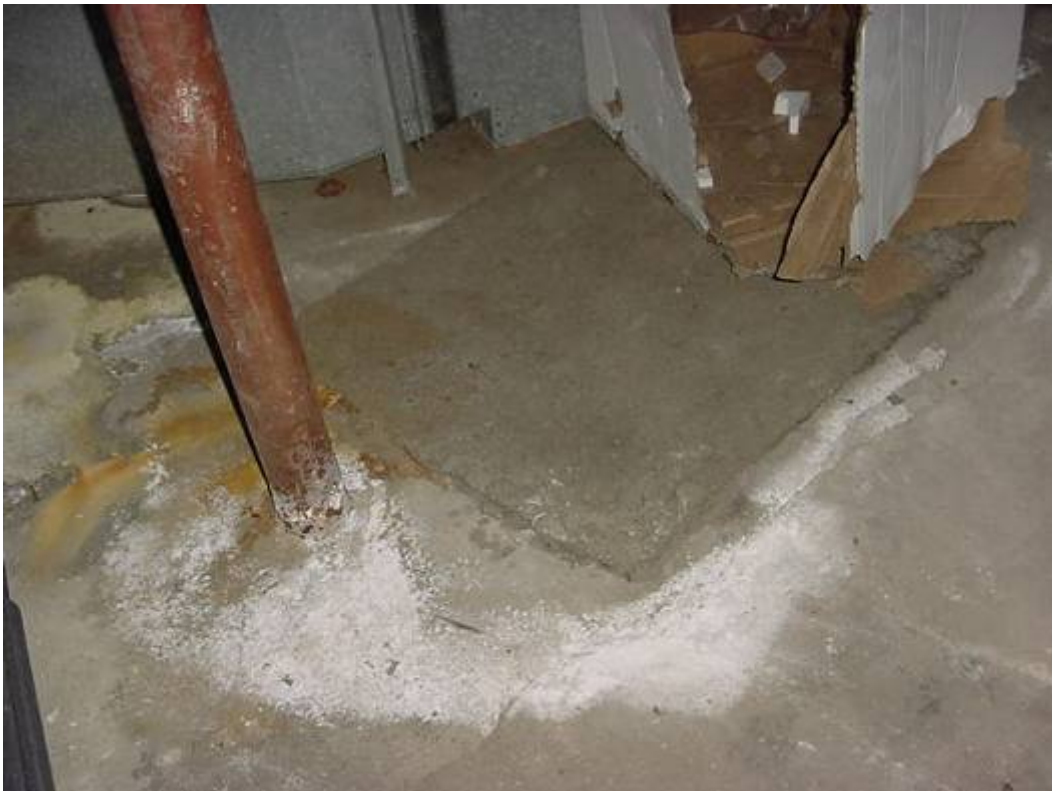
**Picture 8**

**Water Damaged Porous Materials (Carpet Square and Cardboard) Stored on Basement Floor**

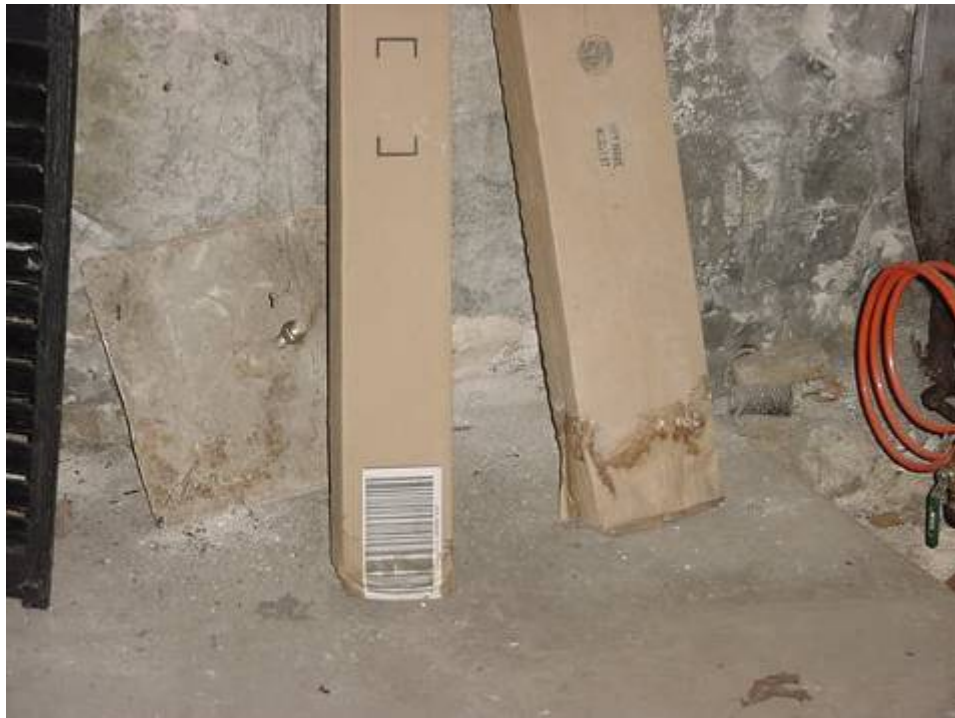
**Picture 9**

**Water Damaged Porous Materials Stored on Basement Floor, Note Water Mark on Cardboard Indicating Historic Water Penetration**

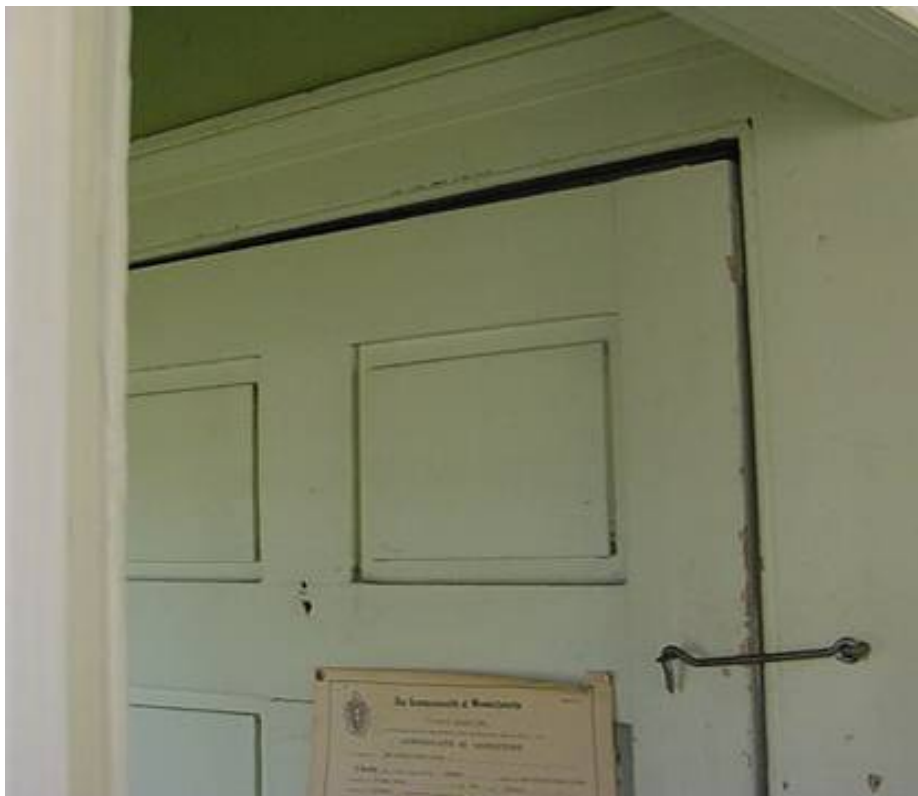
**Picture 10**

Several potential pathways exist for basement odors and particulates to migrate into occupied areas of the building; including spaces around the basement door and utility holes in the ceiling (Pictures 10 and 11). Airflow tends to rise from lower to upper floors, a condition known as the stack effect. The basement door and utility holes should be sealed to minimize airflow into occupied areas.

**Spaces around Basement Door**

4. Seal basement door on all sides with foam tape, and/or weather-stripping. Ensure tightness of door by monitoring for light penetration and drafts.
5. Work with staff to determine which windows are unopenable/difficult to operate and make repairs.

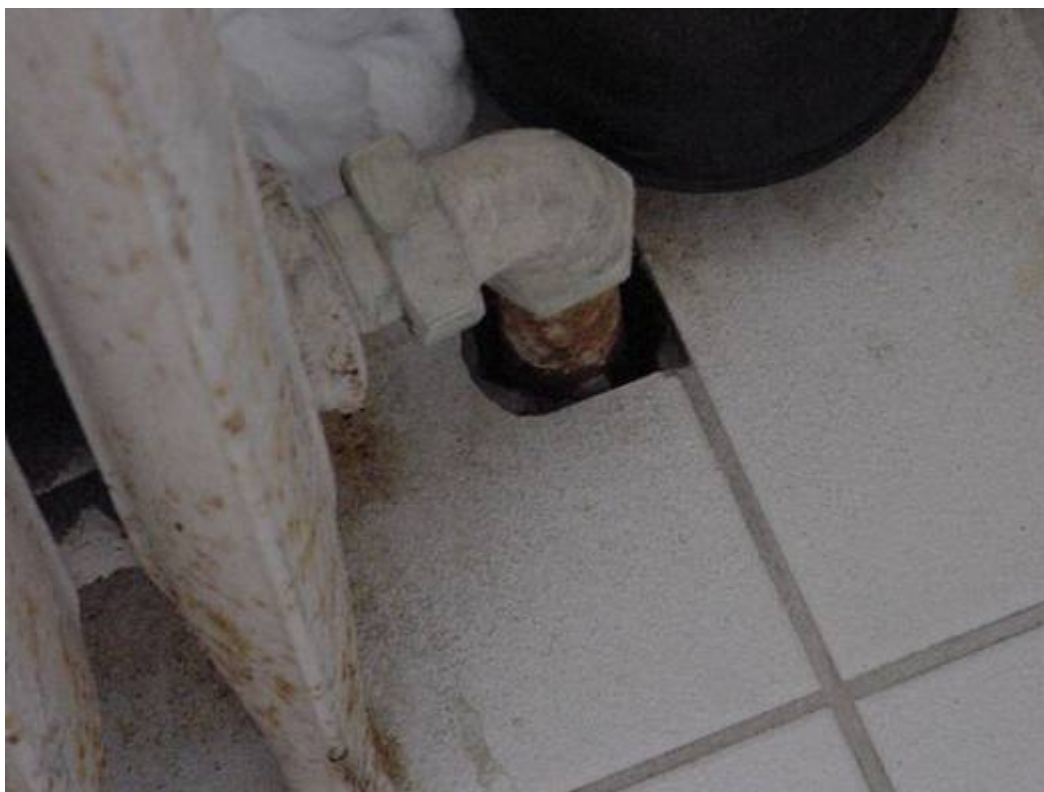
**Picture 11**

**Utility Hole around Pipe in Restroom**

3. Seal utility holes that allow air to travel between the basement and first floor (e.g., around radiator pipes, electrical conduits) to eliminate paths of odor/particulate migration into occupied areas.

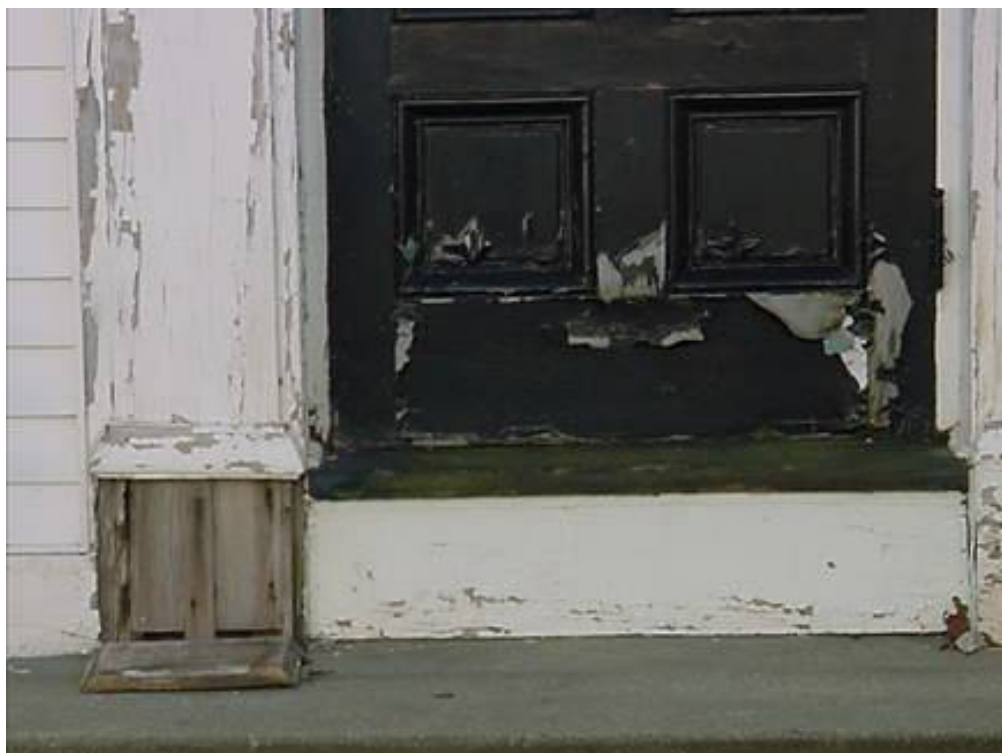
**Picture 12**

- Damaged/rotted woodwork and exterior doors (Pictures 12 and 13);
- Missing/damaged gutters and downspouts (Picture 14); and
- Damaged foundation masonry (Pictures 15 and 16).

The aforementioned conditions represent water penetration sources. Over time, these conditions can undermine the integrity of the building envelope and provide a means of water entry into the building via capillary action through foundation concrete and masonry (Lstiburek & Brennan, 2001). In addition, these breaches may provide a means of egress for pests/rodents into the building.

**Water Damaged/Wood Rot, Side Entrance**

1. Consider consulting with an architect, masonry firm or general contractor regarding the integrity of the building envelope, primarily concerning water penetration through exterior walls. This measure should include a full building envelope evaluation.
2. Consider replacing damaged/worn carpeting throughout the library to prevent the aerosolization of carpet fibers.
3. Repair/replace missing/damaged gutters and downspouts to direct water away from the building.
4. Repair/replace damaged exterior wooden doors and moldings.
5. Consider local exhaust ventilation (e.g., exhaust vent and passive make up vent), in the basement to prevent the infiltration of odors into occupied areas.

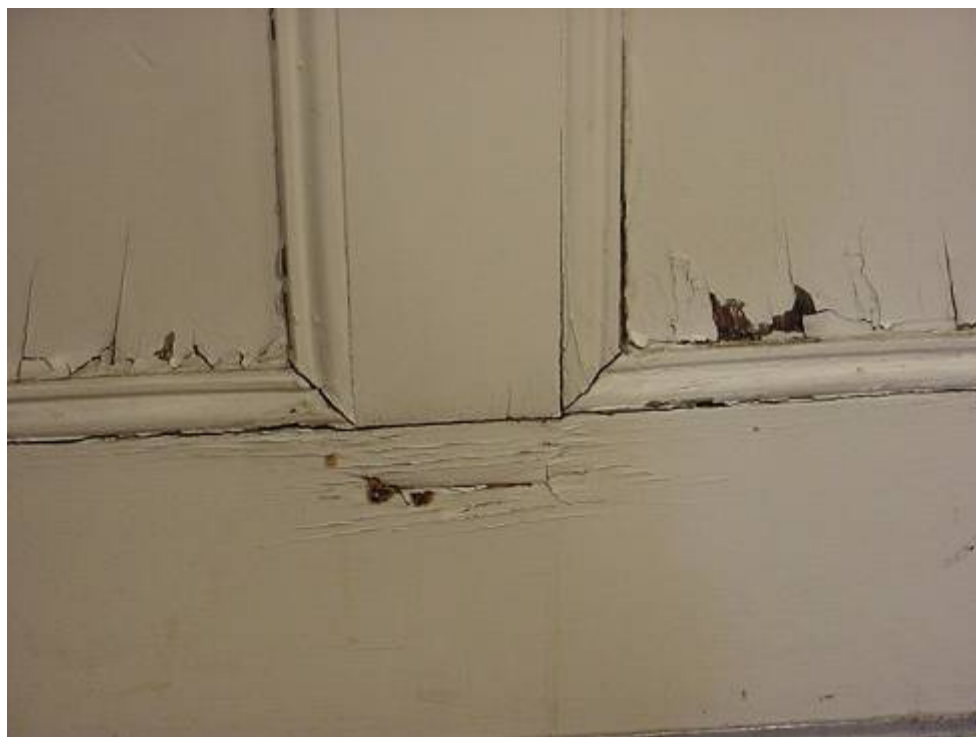
**Picture 13**

**Interior View of Water Damaged/Wood Rotted Side Entrance Door in Previous Picture**

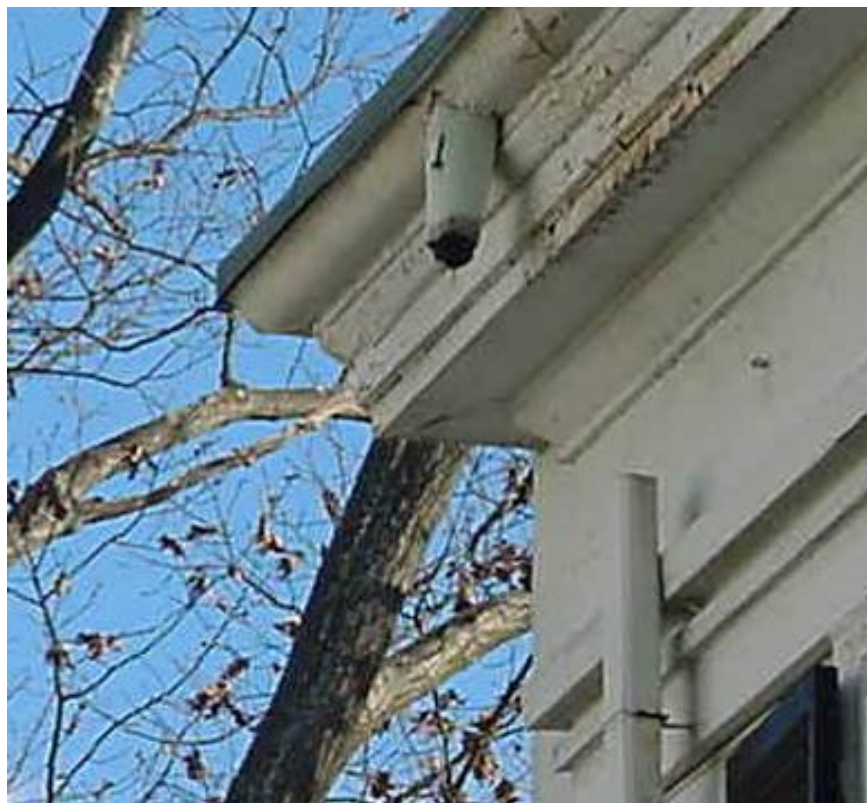
**Picture 14**

**Missing/Damaged Gutter/Downspout System**

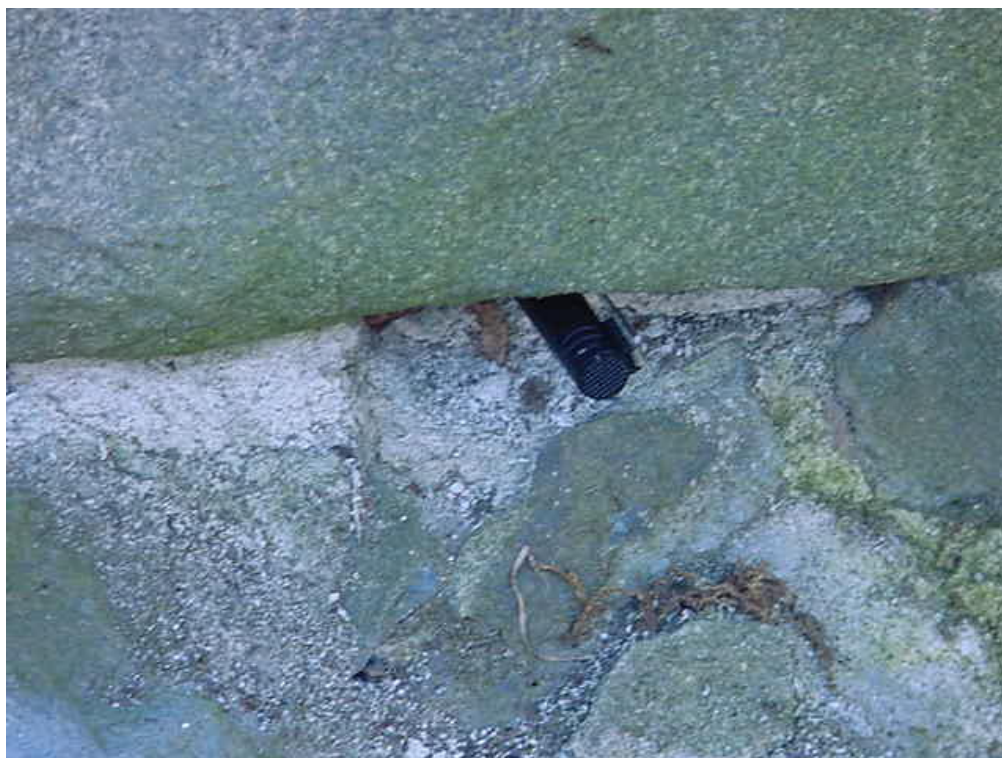
**Picture 15**

**Missing/Damaged Mortar around Flagstone Foundation, Pen Inserted to Show Depth**

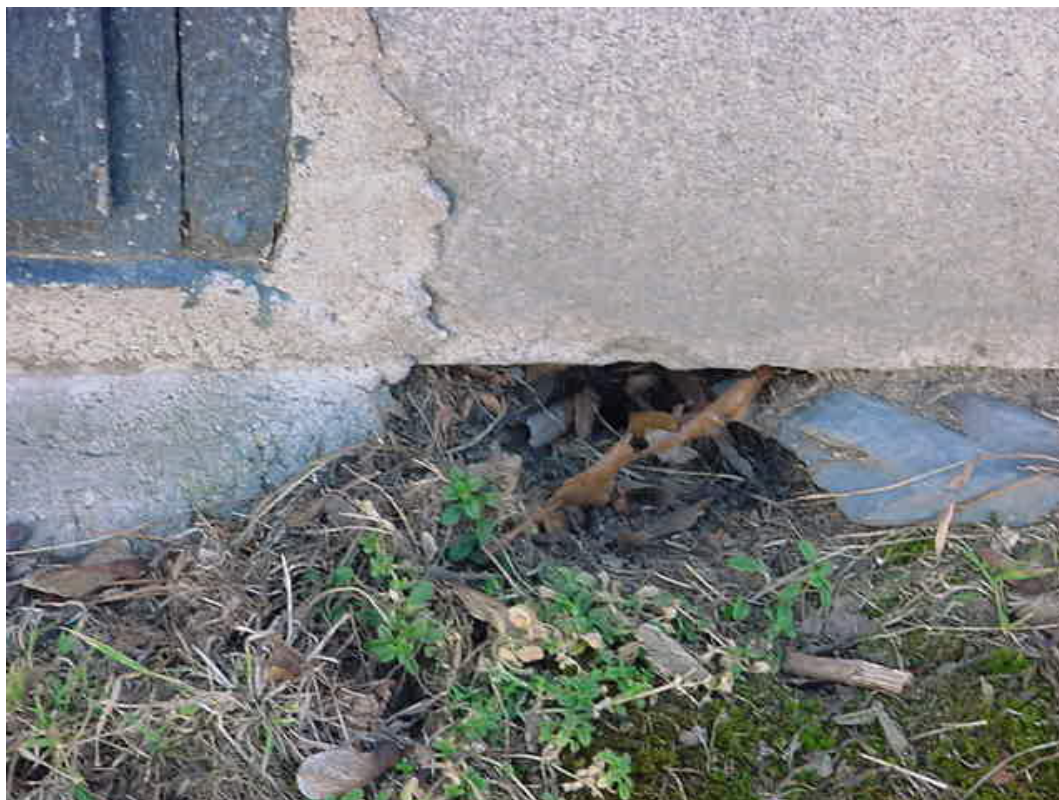
**Picture 16**

**Missing/Damaged Mortar around Flagstone Foundation**

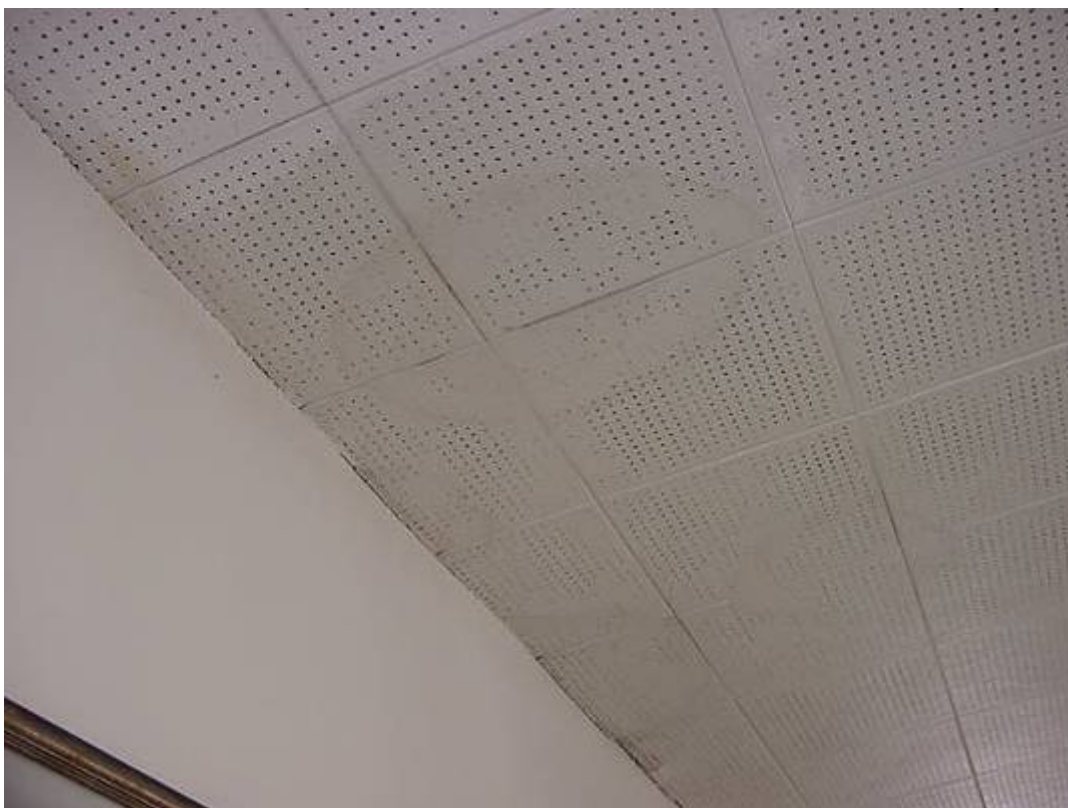
**Picture 17**

Several areas also had water stained ceiling tiles (Picture 16), which were reportedly due to historic roof leaks. Water-damaged ceiling tiles can provide a source for mold growth and should be replaced after a water leak is discovered and repaired.

**Water Stained Ceiling Tiles**

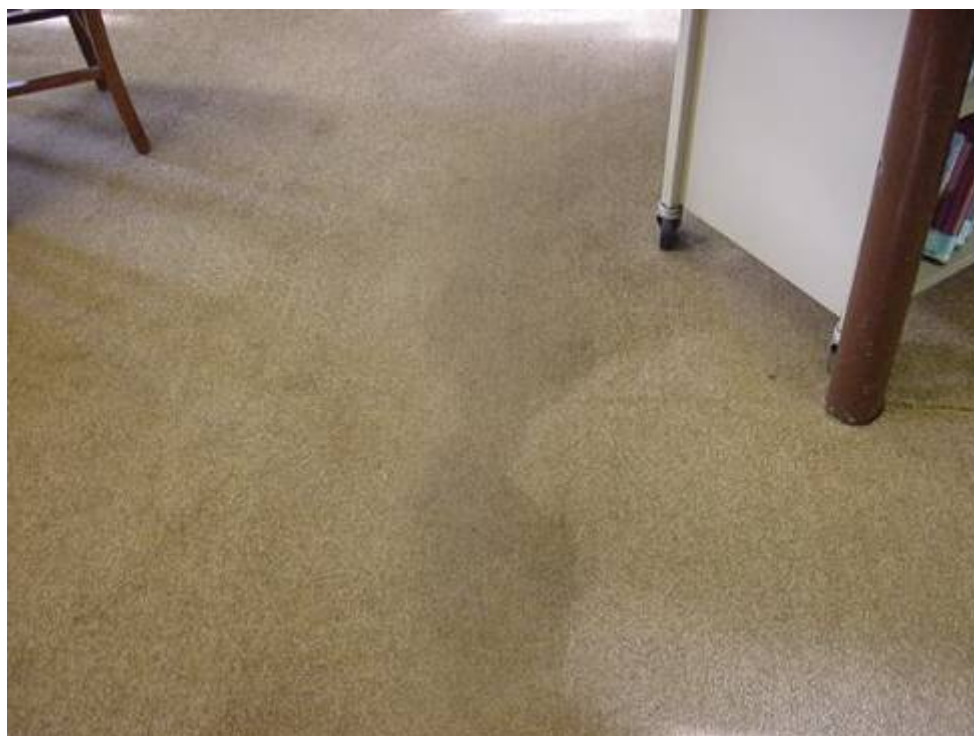
**Picture 18**

Carpeting in several areas was extremely worn, damaged and soiled (Pictures 18 and 19). Disintegrating textiles can be a source of particulates, which can be irritating to the eyes, nose and throat. Carpet fibers/particulate matter can also be entrained and suspended in air by the mechanical ventilation system.

**Stained/Soiled Carpeting**

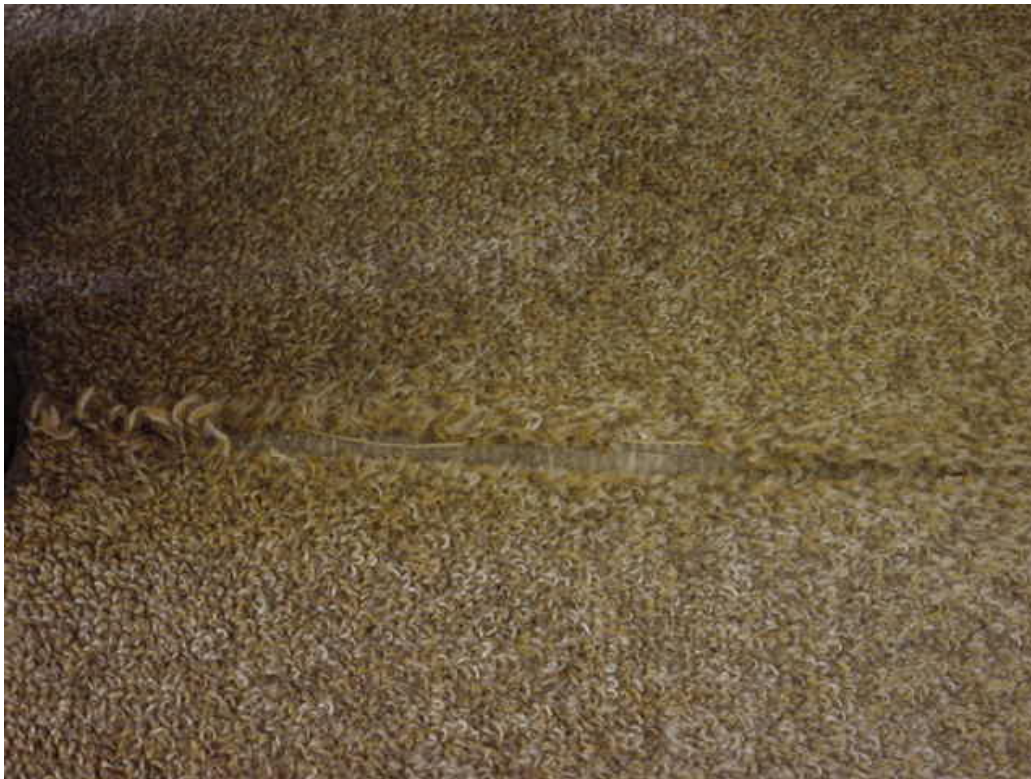
**Picture 19**

**Worn/Damaged Carpeting**

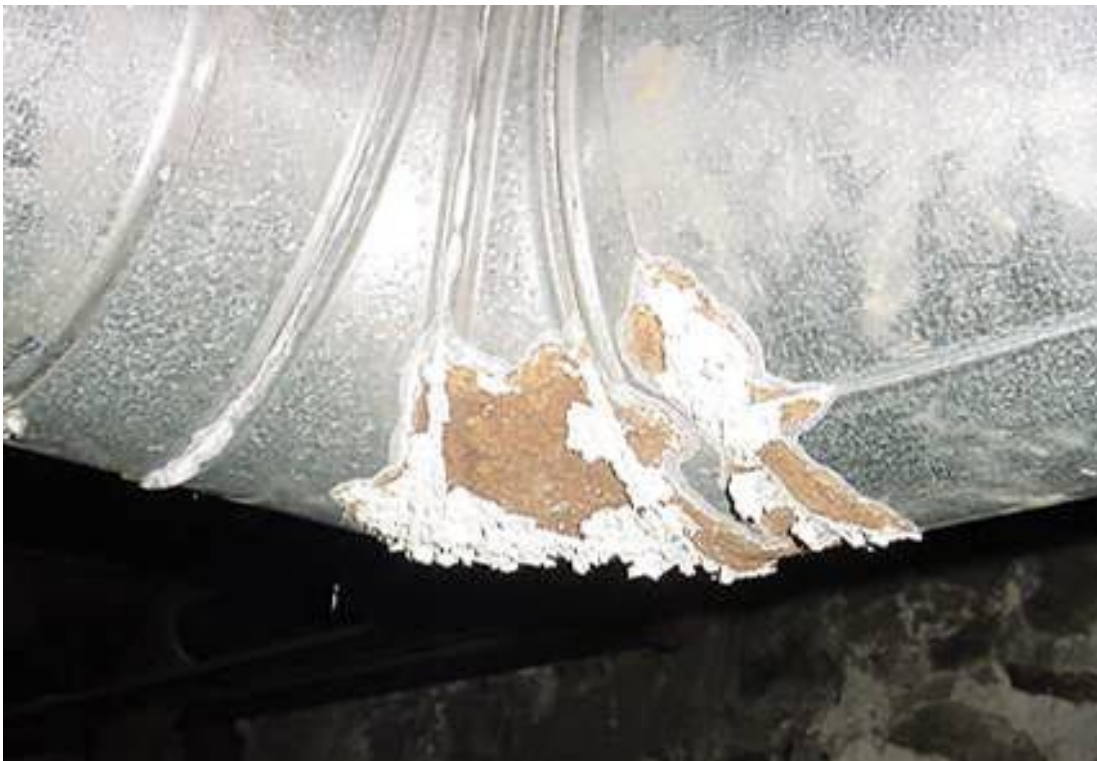
**Picture 20**

Finally, CEH staff observed the exhaust ductwork to the boiler plant to be corroded (Picture 20). If breaches form in the ductwork exhaust emissions such as carbon monoxide can be released in the indoor environment.

**Corroded Section of Exhaust Ductwork for Boiler Plant**

9. Have boiler plant/furnace inspected annually or as per the manufacture's instructions to ensure proper operation. Make repairs to corroded exhaust ductwork to prevent the escape of exhaust emissions into the building.
